Endovascular Repair of the Thoracic Aorta

Use of endovascular techniques to repair thoracic aorta impingement after spinal surgery.

BY PAYAM JARRAHNEJAD, MD; SAMIR GADEPALLI, MD;
ROCCO TUTELA, JR, MD; AND MICHAEL RESNIKOFF, MD

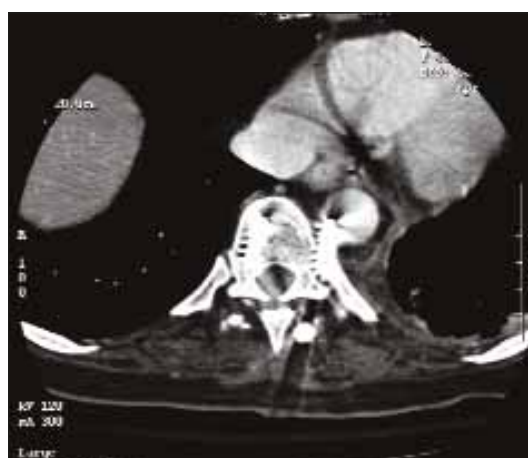
Figure 1. CT scan shows the left lateral interpedicular screws protruding into the posterolateral aspect of the aortic lumen at the T12-L1 level. Although periaortic hematoma is not visualized, penetration into the lumen cannot be excluded.

A 48-year-old woman presented to the emergency department with weakness and fatigue. She had been discharged to a rehabilitation facility 1 month earlier after undergoing several operations resulting from a motor vehicle collision, including a small-bowel resection, splenectomy, diaphragmatic and esophageal repair, inferior vena cava filter placement, and an open reduction and internal fixation of a T11 to L3 fracture. On evaluation, the patient was noted to have stable vital signs and a hemoglobin level of 7.5 mg/dL. A computerized tomography (CT) scan of the chest, abdomen, and pelvis revealed that the screws used to fix the spinal column were impinging on the lower thoracic aorta. A repeat CT scan with 1.5-mm cuts showed that the left lateral interpedicular screws at the T12-L1 level were causing deformity of the posterolateral aspect of the aortic lumen and penetration into the lumen could not be excluded, although there was no periaortic hematoma visualized (Figure 1). A subsequent mag-

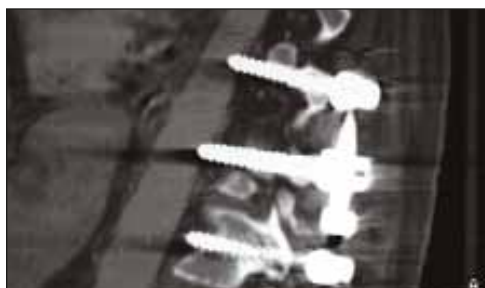
Figure 2. Magnetic resonance imaging reveals screws impinging on the aorta.

netic resonance image also revealed that the screws were impinging on the aorta (Figure 2).

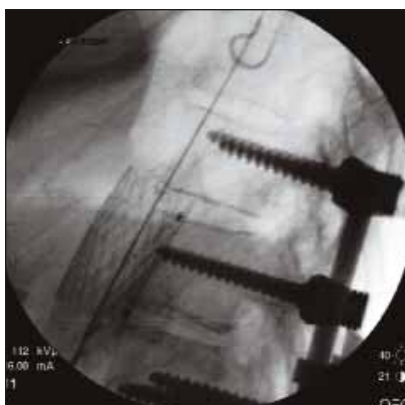
Figure 3. Angiography demonstrates initial stent placement over the caudal screw.

A 26-cm-diameter AneuRx aortic cuff (Medtronic, Inc., Santa Rosa, CA) was fed over the Lunderquist wire and positioned just over the caudal screw. The cuff was then removed, runners taken down, and expansion onto the vessel lumen was noted (Figure 3). The caudal pedicle screw was removed. An angiogram revealed brisk flow of contrast through the covered stent, without evidence of a leak. The cephalad screw was removed in a similar manner. Another 26-cm-diameter AneuRx aortic cuff was deployed over this screw as it was backed out (Figure 4). Repeated angiography revealed no evidence of a leak (Figure 5).

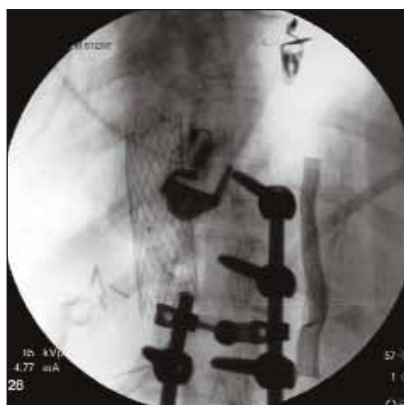
Figure 4. Angiography demonstrates both stents in the aorta after removal of the two screws.

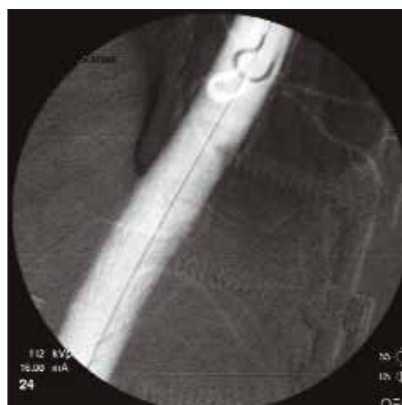
Figure 5. Final angiogram reveals no evidence of a leak.

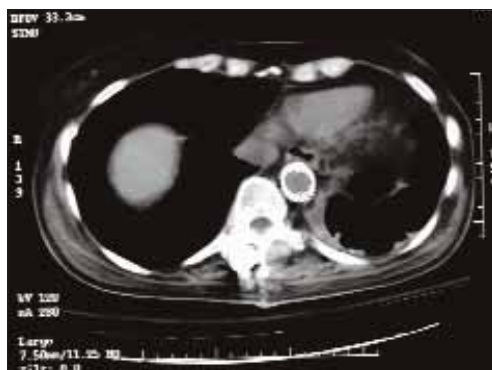
Figure 6. CT scan demonstrates stability of the spine and acceptable position of the stents without evidence of a leak.

repeat CT scan at that time demonstrated stability of the spine and acceptable position of the stent without evidence of a leak (Figure 6).
