Endovascular SA and IMA Repair After Iatrogenic Injury

A case report of simultaneous inadvertent injury to both the subclavian and internal mammary arteries treated with endovascular techniques.

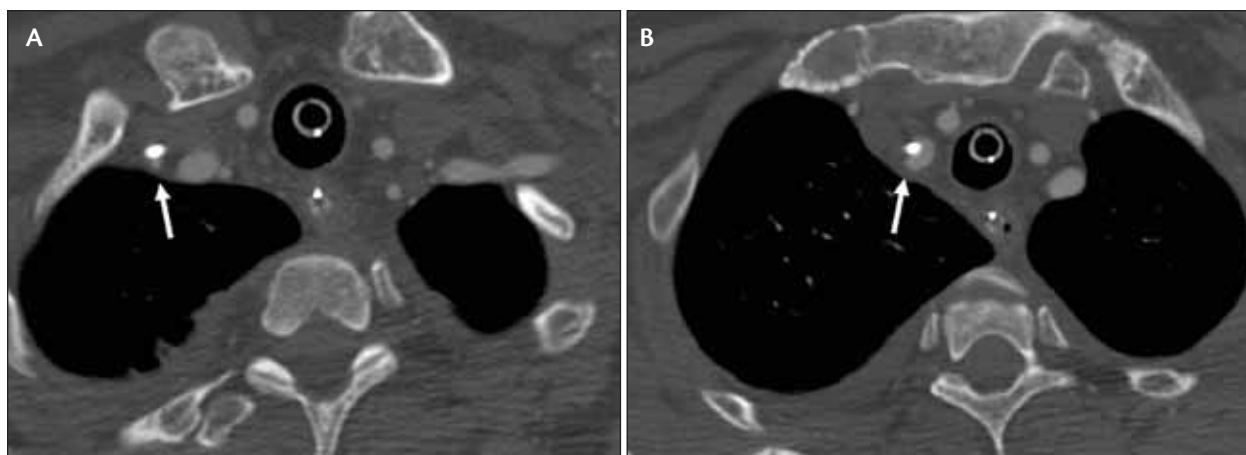
Figure 1. CT angiogram of the chest shows a central line passing along the anterior surface of the right internal mammary artery (IMA) (A) and entering the right SA (B).

mal to the origin of the vertebral artery (VA). The line passed along the anterior surface of the right IMA (Figures 1 and 2). After discussion of treatment options, the patient was referred for angiography.

vessel entry site, determines the proximity of the catheter-to-branch vessels or other vital structures, and is useful in planning the preferred method of treating the arterial injury. In our case, the CT angiogram showed the arterial entry site into the SA to be central to the origin of the VA and showed a long extravascular course of the catheter, which raised the concern that a closure device may not be able to be deployed safely. In addition, the CT angiogram showed potential traversal of the IMA, which provided another reason against using a closure device.

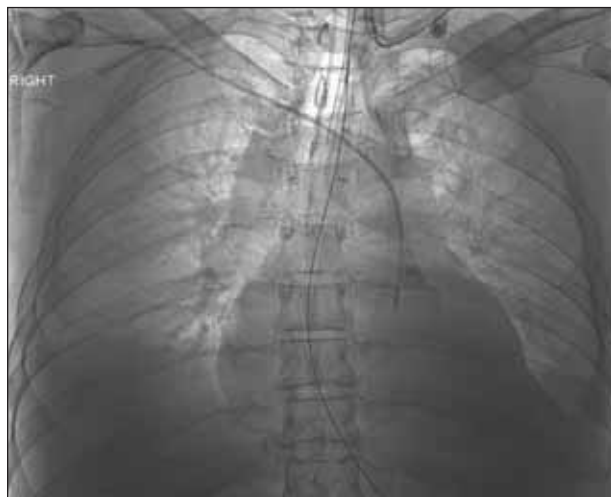
Figure 2. Chest x-ray showing a central line placed into the right SA.

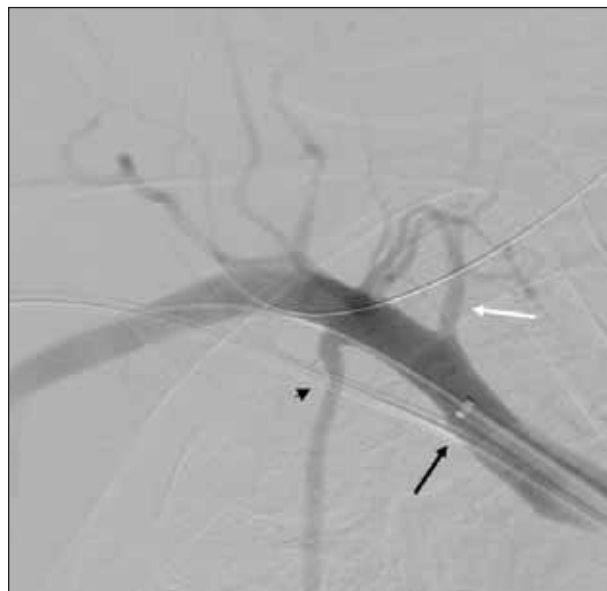
Figure 3. A right subclavian angiogram shows the central line traversing the right IMA (black arrowhead) and the right SA (black arrow) just proximal to the right VA (white arrow).

Catheterization of the innominate artery from the femoral approach was performed. Angiography confirmed intra-arterial placement of the central line, with the entry site between the origin of the right VA and the right common carotid artery (CCA) (Figure 3). The decision was made to place a covered stent across the entry site in the SA. A covered balloon-expandable stent (iCast, Atrium Medical Corporation, Hudson, NH) was advanced through the femoral access and positioned across the entry site. The central line was removed over a safety guidewire while the stent was deployed in the SA across the entry site. The purpose of the safety wire was to maintain access in case the stent deployment failed to control the bleeding, so a dilator could be advanced to tamponade the bleeding while the next step was planned (Figure 4).

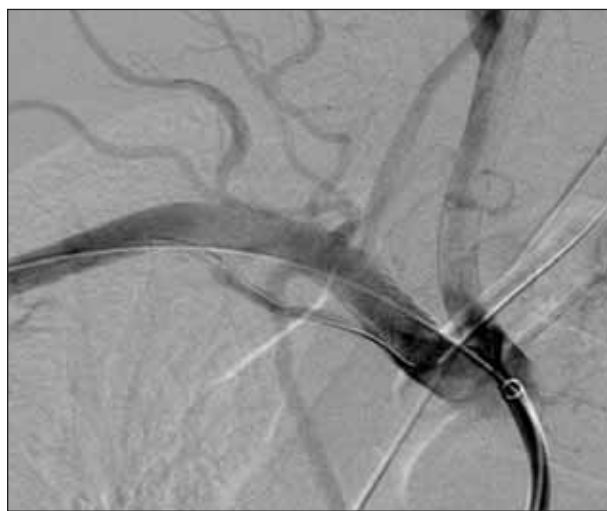
Figure 4. An angiogram after central line removal over a guidewire and covered stent deployment in the proximal SA shows persistent contrast filling of the tract, with the IMA as a potential source of extravasation.

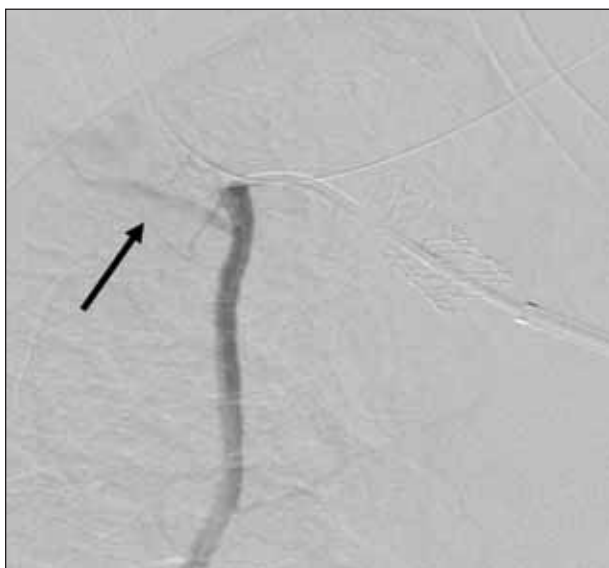
Figure 5. Selective catheterization of the right IMA shows contrast extravasation (arrow).

A follow-up angiogram showed persistent contrast extravasation from an injury to the right IMA that also appeared to be related to the central line. This was confirmed by catheterization of the IMA (Figure 5). Next, a microcatheter (Progreat, Terumo Interventional Systems, Somerset, NJ) was negotiated distal to the extravasation site. Multiple coils were deployed in the IMA (detachable hydrogel Azur coils, Terumo Interventional Systems), distal then proximal to the extravasation site, to prevent back bleeding. A follow-up angiogram showed complete occlusion of the IMA and patency of the SA, VA, and CCA, with no contrast extravasation (Figure 6).

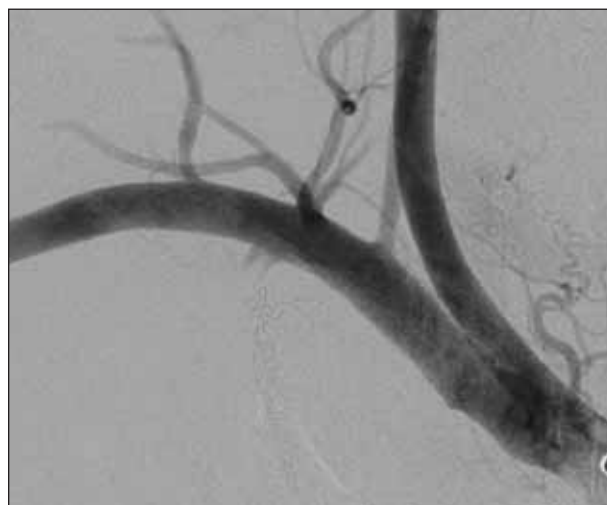
Figure 6. A completion angiogram after coil embolization of the IMA and covered stent placement in the proximal SA shows no contrast extravasation and preservation of flow to the VA.

This case demonstrates that additional injuries must be considered. These may arise from additional attempts to access the subclavian or jugular vein and can be fatal if left unnoticed.⁹ In our case, the patient had a simultaneous injury to the proximal IMA just beyond its origin, which was traversed by the central line. Extravasation was only noted on angiogram after the line was removed and was not seen on CT because of the tamponade effect of the catheter. We prefer coil embolization to treat such injuries. Detachable coils (Azur) were used for the IMA embolization, because there was little proximal landing zone for multiple coils in the proximal IMA. The operators avoided embolization of the SA and maintained patency of the SA.
