# Repair of a Bilobed Descending Aortic Aneurysm

BY DANIEL J. TORRENT, MD, AND MICHAEL C. STONER, MD, RVT, FACS

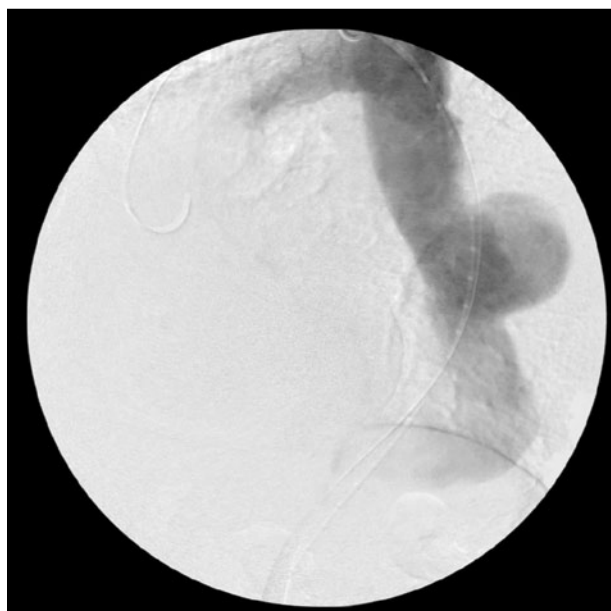
Figure 1. Intraoperative angiogram showing the aneurysm.

The patient was admitted for elective repair and taken to the operating room. Percutaneous access was achieved through the right common femoral artery. A left common femoral artery cutdown was performed for access on that side. Catheters were advanced through the femoral arteries into the aortic arch, and systemic heparin was administered. Angiography was performed to show the saccular aneurysm (Figure 1). A 42 X 150 mm

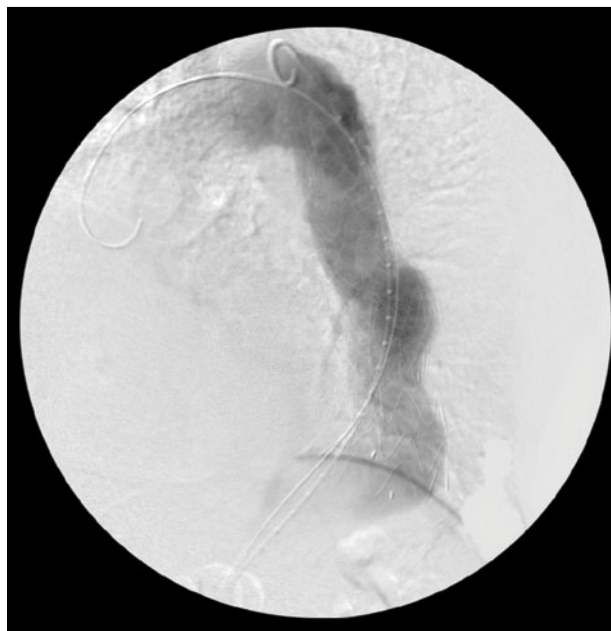
**Figure 3.** Completion intraoperative angiography after stent deployment.

A right femoral cutdown around the 5 F sheath was then performed, and the device was passed through the femoral artery and a very tortuous right iliac artery over a wire. With the device in place, a thoracic aortic angiogram showed that the graft was in a good location, and the stent was deployed. Completion angiography showed appropriate deployment and opposition against the aortic wall with exclusion of the aneurysm sac (Figure 3). The catheters, wires, and sheaths were removed with fluoro-
