Embolization for a Spontaneous Chest Wall Hemorrhage

BY BRIAN S. GELLER, MD, AND CHRIS STEPHENS, MD

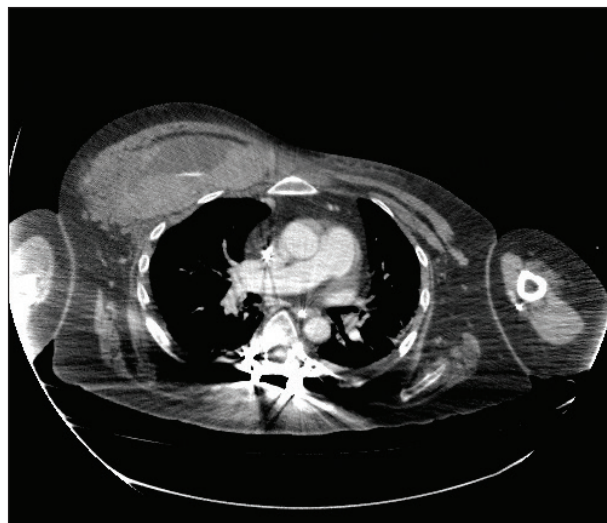
Figure 1. A CT scan showing active hemorrhage.

After using standard techniques to access the right common femoral artery, a 5-F (1.67-mm) sheath was placed. Subsequently, a VERT catheter and a hydrophilic guidewire were used to cannulate the right axillary artery. An angiogram failed to show the source of bleeding (Figure 1). The VERT catheter was retracted and, using a 0.021-inch (0.53-mm) Direxion™ Torqueable Microcatheter and Fathom®-16 Guidewire, the thyrocervical trunk was cannulated. The following angiogram result was also negative.

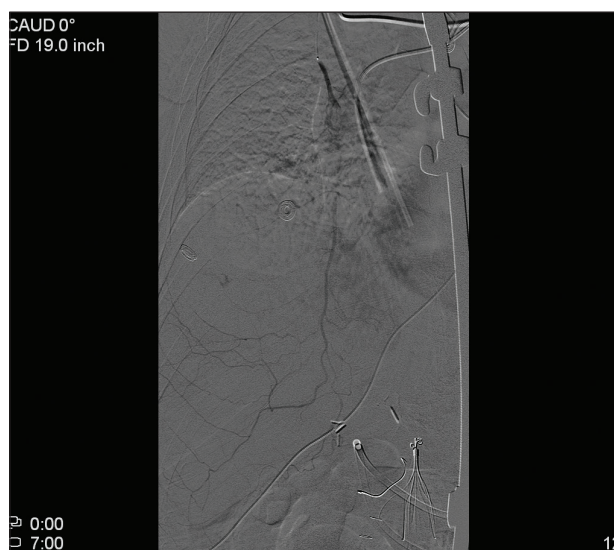
Figure 2. An angiogram showing questionable blush.

and Fathom®-16 Guidewire were used to cannulate the right internal mammary artery. The angiogram showed a questionable blush (Figure 2). The Direxion™ Microcatheter was advanced below the level of the diaphragm. The angiogram showed active hemorrhage from a perforator vessel (Figure 3). Gelfoam slurry was instilled through the Direxion™ Microcatheter. A follow-up angiogram showed no further hemorrhage from that artery; however, two additional vessels were bleeding (Figure 4), which also responded well to gelfoam (Figure 5).

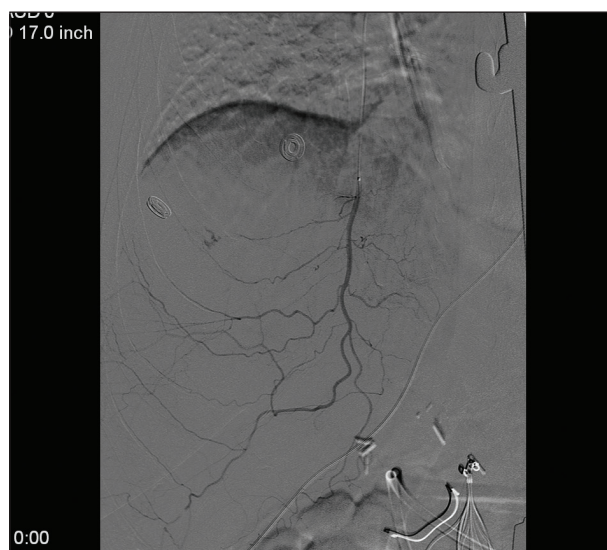
Figure 3. There was active hemorrhage from a perforator vessel.

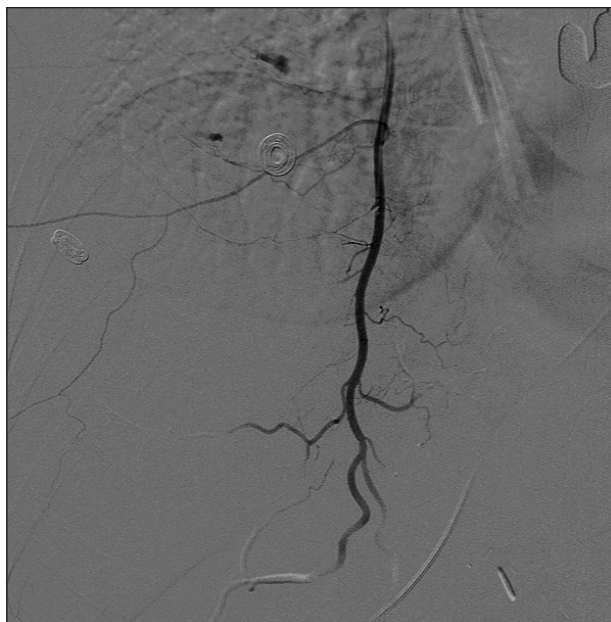
Figure 4. Gelfoam slurry resolved the initial hemorrhage, but two additional areas of bleeding were found.

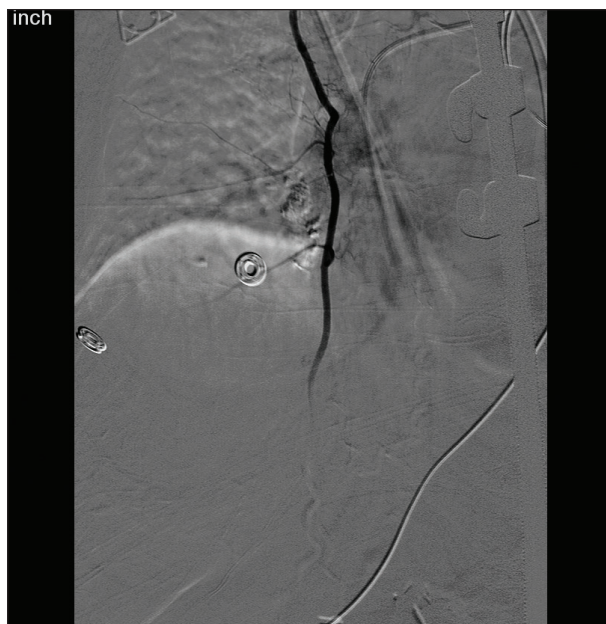
Figure 5. The final angiogram showing no area of active hemorrhage.
