# **SURGICAL SAVES**

Surgeons share observations in and  
responses to complex scenarios.

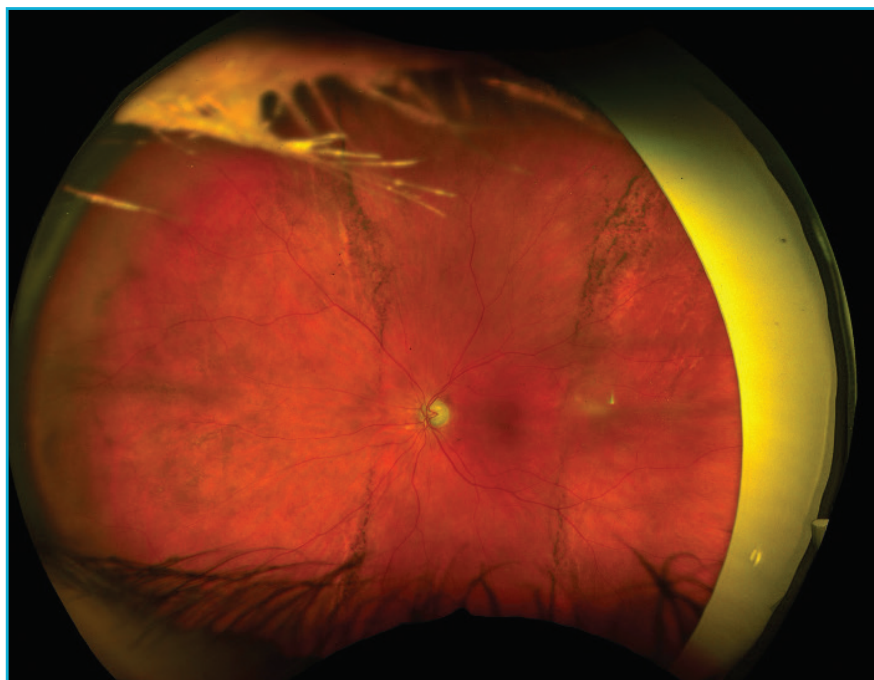
Figure. The patient's left eye 1 year after choroidal drainage following tube shunt surgery.

A 56-year-old patient presented with IOPs in the 30s mm Hg despite being on maximum tolerated medical therapy. I elected to first treat the left eye, which had more significant visual field loss than the right, with placement of a valved tube shunt. Postoperatively, the patient developed hemorrhagic appositional (kissing) choroidals, which were subsequently drained 1 week later. Ultimately, this left him with decreased vision due to demarcation lines, one of which crossed through the macula (Figure). A non-traditional subconjunctival surgery was elected for treatment of the patient's right eye. Surgeries that carry a risk of severe hypotony (which can occur with any subconjunctival procedure) can have profound impacts on patients' visual recovery.

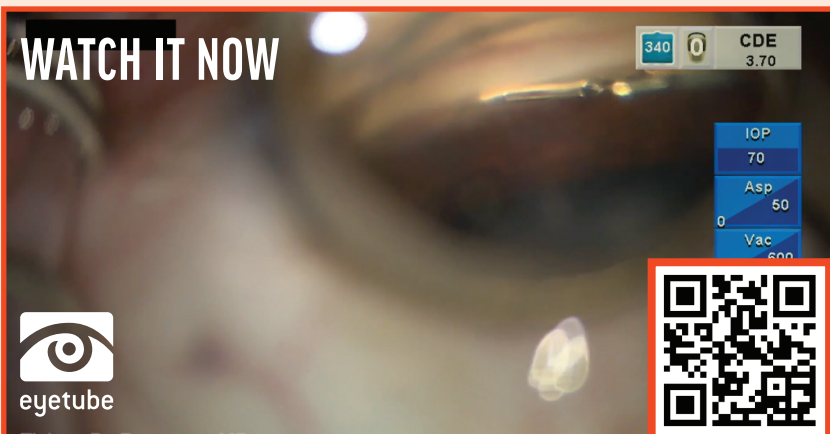
**Microstent Redirection | Ticiana De Francesco, MD**

to deploy the Hydrus Microstent into Schlemm canal, I realized that part of the device was going into the suprachoroidal space.

To implant a Hydrus Microstent successfully, the distal tip of the injector cannula should be angled to around 30° upward while the inner wall of Schlemm canal is incised and the device is deployed. It is important to avoid incising the inner wall of the canal too superficially. Before deploying the stent, I relax my hand to minimize stress on Schlemm canal. Then, I slowly deploy the Hydrus while watching to confirm that the whole microstent is entirely positioned in the canal. ■
